## BEICKER MARTINEZ ENGINEERING

August 8, 2013

Re: **Stein Building Investigation**  
Main Street  
Uvalde, Texas

BME Project #12413-1

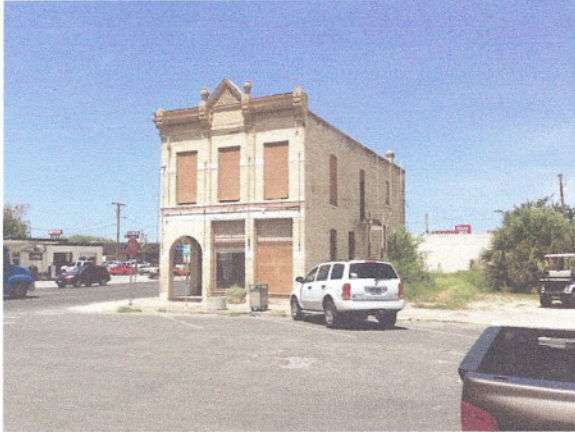
**Photo #1:**

General photo of the front entry of the structure.

- Note taller parapet at the front wall.
- Note the boarded windows.
- Note the grade elevation to the right/south side of the building.

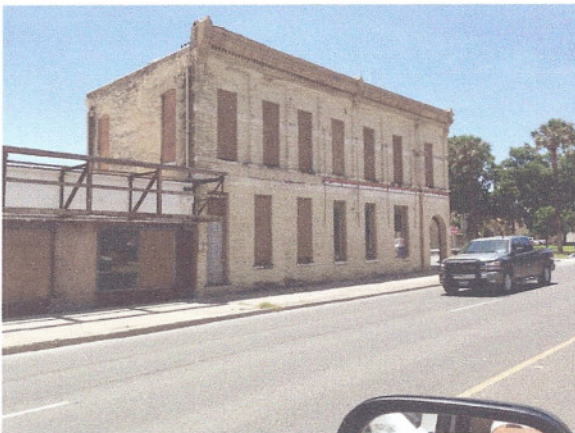
**Photo #2:**

General photo of the structure along Main Street/Hwy 90.

- Note taller parapet at the wall along Main Street/Hwy 90.
- Note the boarded windows.
- Note the adjacent single story building on the east side.

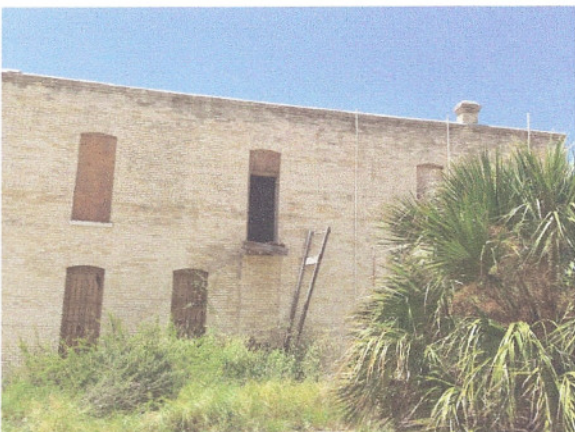
**Photo #3:**

General photo of the south side of the structure.

- Note the unprotected opening at the second floor.
- The landing at the second floor is non functional.

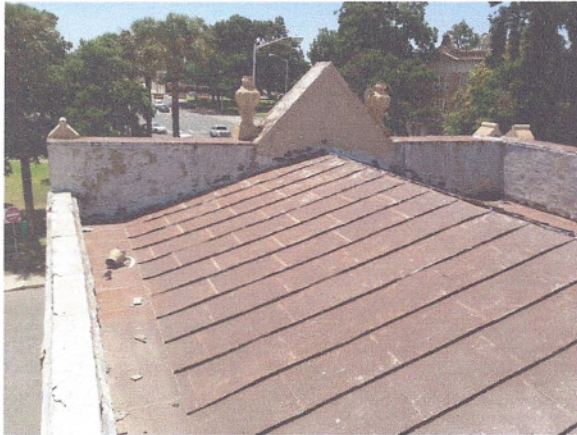
Photo # 4:

General photo of the roof looking west

- Notice the wall parapet (part of wall above the roof) is taller along the west and north sides of the structure.
- Metal roof covering in decent shape.
- Notice metal coping/cornice at top of taller parapet walls.

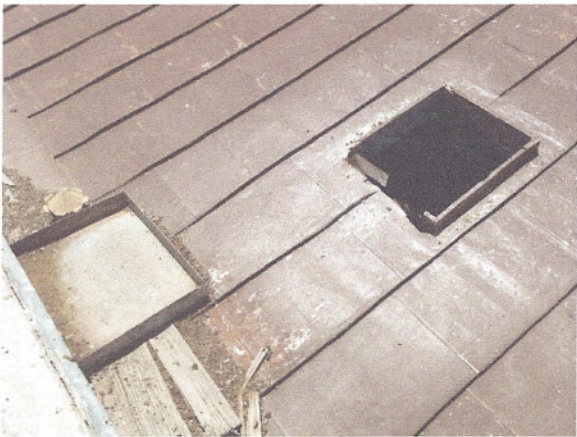
Photo #5:

The hatch covering on the roof at the south wall is open, which currently allows water to enter into the roof structure and fall directly onto the second floor. The roof trusses adjacent to the hatch opening have rotted in some locations where they bear into the masonry. Replace/repair roof trusses in this area as needed and install, seal and secure hatch cover. All roof framing shall be reviewed and repaired as needed.

Photo of center of roof area at hatch location

- Hatch opening – unprotected.
- Debris and dirt at the flow line of the roof system.

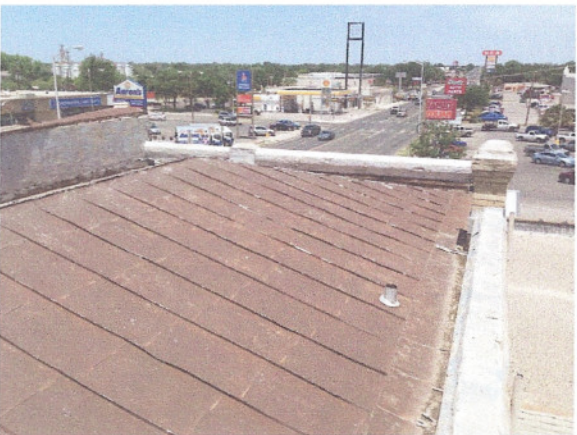
Photo #6:

General roof photo looking east.

- Notice the roof hip condition at the east end of the roof.
- Notice the vent with no cover

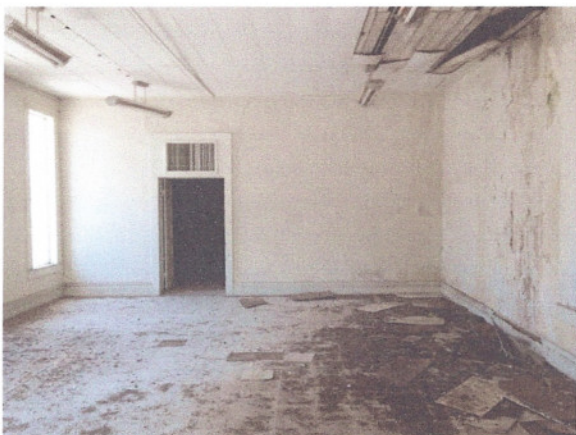
Photo #7:

General photo of the first floor area.

- Rotted floor
- Rotted ceiling/floor framing above.
- Water damage on walls.
- Cracks on plaster walls.

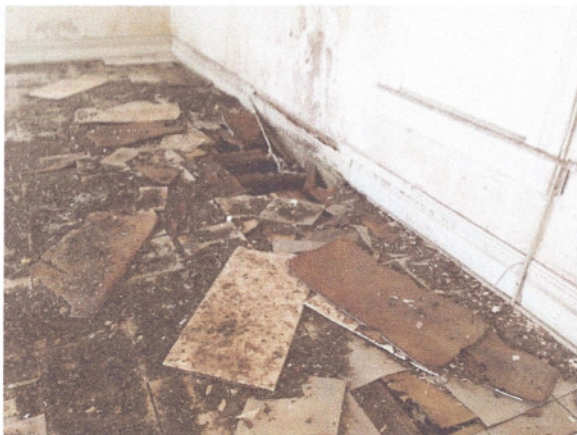
Photo #8:

General photo of south wall at the first floor.

- Notice the amount of dirt and bird feces.
- Rotted floor members.

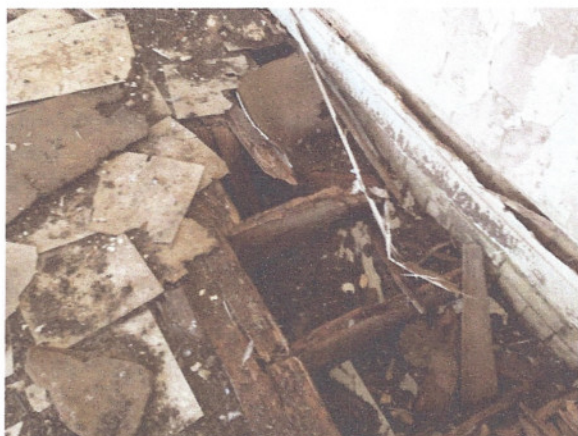
Photo #9:

The floor joists that bear on the south wall have come into contact with the grade below thereby causing the joists to rot. A similar condition is appearing along the north wall (main street side). I recommend that all of the floor decking and floor joists be removed and the grade below be reworked to establish the code-required clearance under the floor joists and to allow for proper drainage and ventilation. In addition, a significant amount of the floor joists will either need to be repaired or replaced. Replacing the floor joists will also require most of the wood flooring/decking to be replaced. Additional investigation is needed to confirm that a beam/bearing support line is present under the first floor to support the floor joists at their mid-span and to determine the structural condition of that beam line. In order for the first floor to support an office loading condition, a bearing line along the center of the building needs to be confirmed to exist. If no support line is present, a new bearing condition will need to be constructed for occupancy.

General photo of south wall at first floor.

- Notice rotted floor joists.
- Notice joist bearing directly on dirt below.
- Notice water stains on walls.
- Notice floor deck boards rotted.

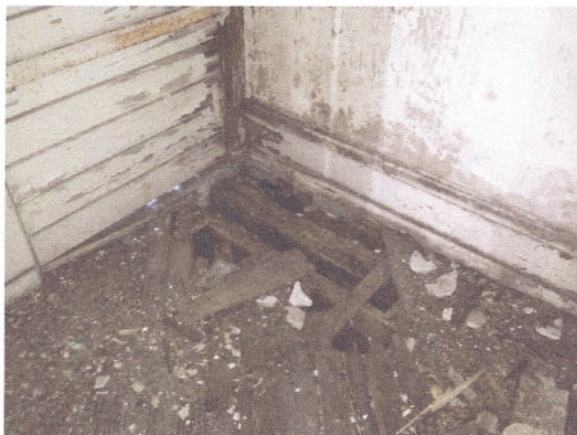
Photo #10:  
General photo of floor at the northeast corner of the structure.

- Notice rooted floor joists.
- Notice rotted floor decking.
- Notice daylight at base of wall.

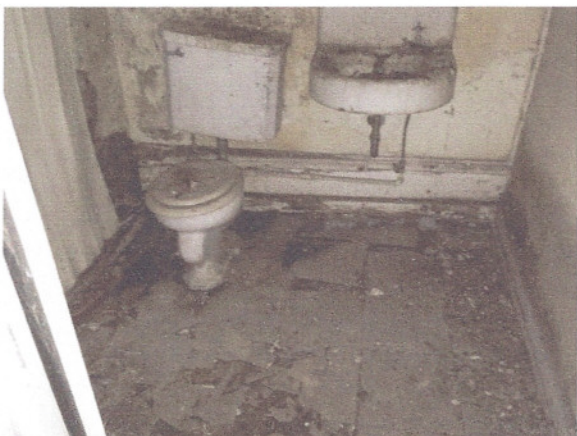
Photo #11:  
General photo of bathroom area.

- That is bird feces all over the place.
- Notice floor near the base of the toilet rotted.
- Notice water stains on walls.

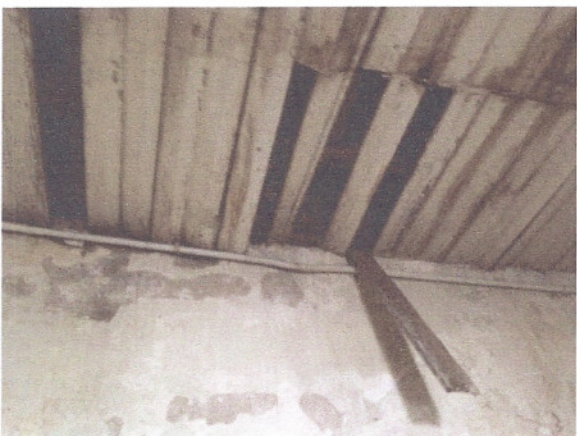
Photo #12:  
General photo of the interior side of the east wall looking up at the ceiling of the second floor.

- Notice the stains and damage to the ceiling planks.
- Notice planks not properly secured to the floor framing above.

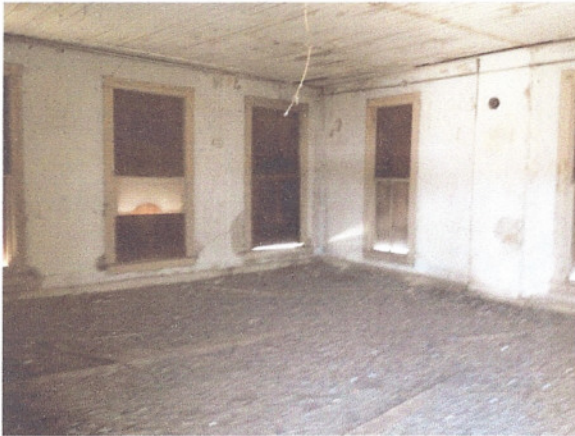
Photo #13:  
General photo of the interior area of the second floor viewing the northwest corner.

- Notice the water stains on the walls.
- Notice the cracked plaster on walls.
- Notice some water damage to the ceiling.

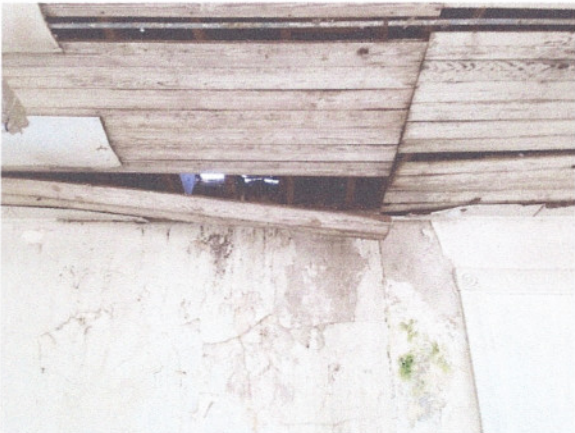
The floor joists bearing into the south wall have deteriorated due to water/rot damage. These joists are located below the roof hatch and door-opening location from above and in my opinion water from these openings above is causing this damage. The damage to the joists is causing the joists to begin to lose bearing support at the masonry. The 1x4 floor decking has rotted at this location as well. Based upon the existing condition the second floor is not safe for loading (no one allowed to walk on second floor) until the floor joists and decking are repaired.

Photo #14:  
Photo of first floor ceiling at the south wall.

- Notice daylight – daylight is the opening for the door at the second floor
- Notice the cracked wall plaster.

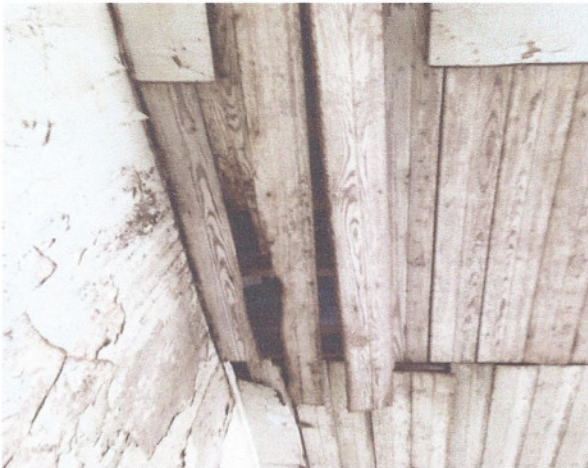
Photo #15:  
Photo of first floor ceiling at the south wall.

- Notice peeling paint
- Notice water stains.
- Notice water damage to ceiling planks.

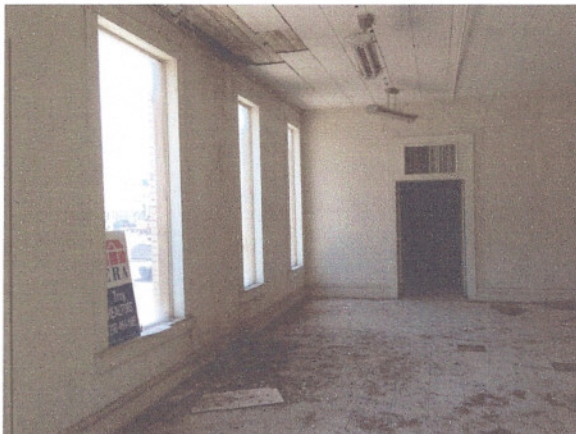
Photo #16:  
General photo of the north wall (Hwy 90) and the east wall (w/door).

- Photo is showing similar deterioration along the north wall but to a lesser degree.
- Notice cracked plaster on the wall beyond.

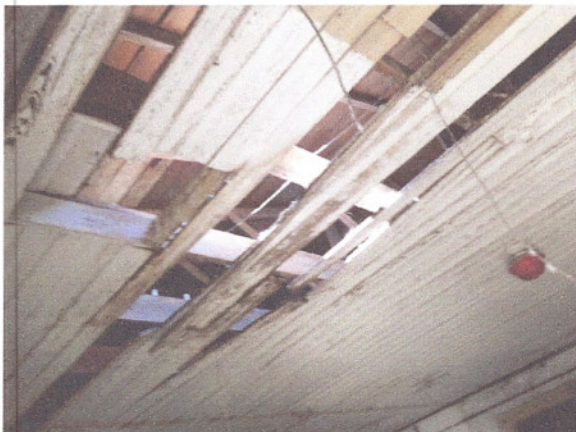
Photo #17:  
General photo of the second floor ceiling

- Ceiling planks are missing, broken or loose.
- Notice the 2x ceiling framing spanning from wall to wall.
- Notice the 1x roof decking.
- Notice the lack of maintenance.
- Birds are nesting above ceiling.

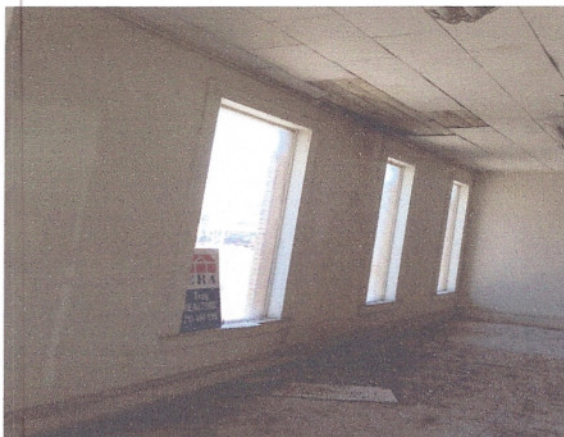
Photo 18:  
General photo of first floor north wall

- Deterioration of the ceiling along the north wall.
- Notice the water stains on the wall.

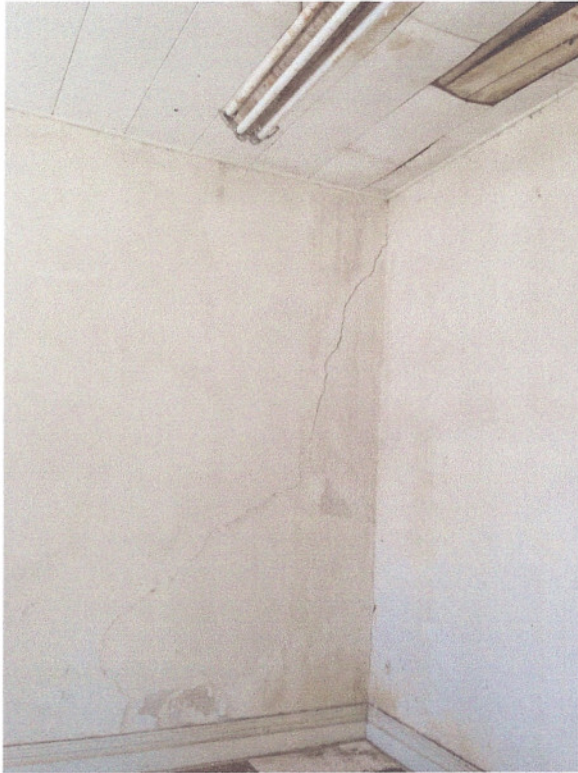
Photo #19:  
Photo of interior corner of first floor viewing to the southeast.

- Notice the water stains on the walls.
- Notice the cracked plaster.
- Notice the water on the ceiling.

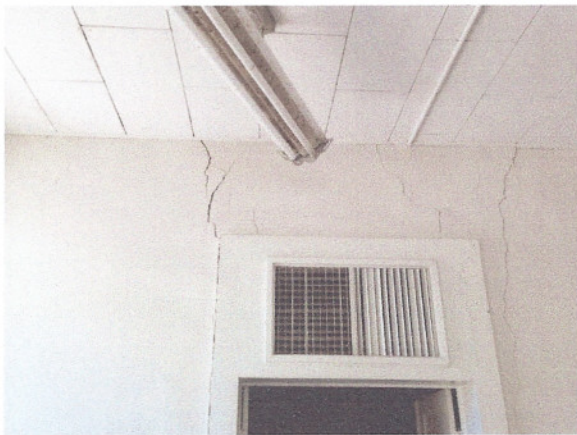
Photo #20:  
Photo is looking to the east at the interior partition wall.

- Notice the cracked plaster.

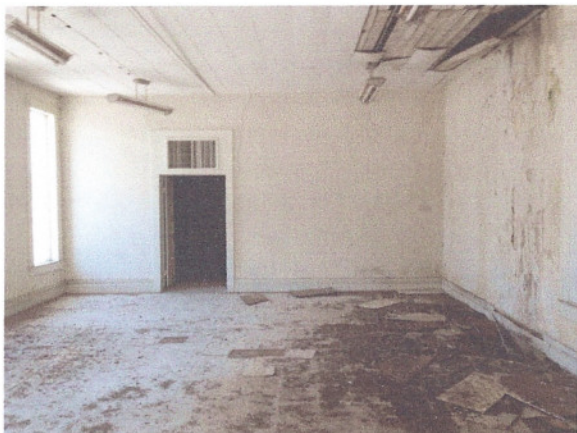
Photo #21:  
Photo is looking at the east wall (w/door).

- Notice the extent of water damage on the south wall.
- Similar damage is occurring on the north wall (see photo 16 and 22).
