**FARMERS AND MERCHANTS BANK
PILOT POINT, TEXAS
MASTER PLAN**

**Prepared for
Pilot Point Economic
Development Corporation
Pilot Point, Texas**

Quimby McCoy Preservation Architecture, LLP
3200 Main Street #3.6
Dallas, Texas 75226

February 28, 2018

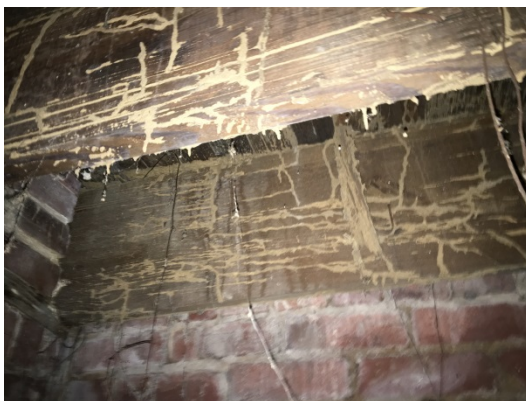
Fair to Poor. Approximately three joists along the east wall have termite damage. The porch area on the south side approximately two thirds down the building contains floor boards, joists, and beams that are rotted and failing. The foundation beneath the west wall has settled and caused rotation of the wall.

Figure 1. Termite damaged floor joists.

The floor joists with termite damage need to be replaced. The porch floor boards, joists, and beams need to be replaced with new boards (if the original design is to be kept) or replaced with a more durable material since this area is constantly exposed to the environment. The foundation of the west wall should be replaced with a new concrete foundation.

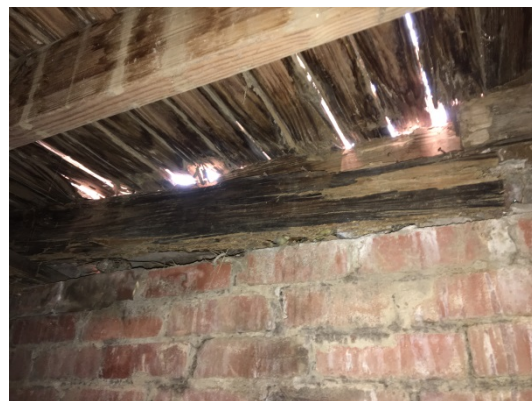
Figure 2. Deteriorated boards, joists and beams at porch.

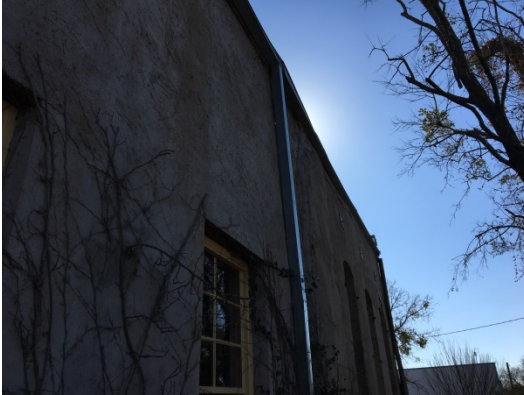
Poor. The back room contains cracking in the wall over the opening to the hallway. This wall appears to be wood with plaster overlay. The south wall of the back room contains cracking in the brick. The west wall of the back room is tilting outward approximately five inches at the worst case.

Figure 3. West wall deflection.

Priority Level 1: Demolish and replace the west wall of the back room. This would require shoring of the roof joists in the back room.

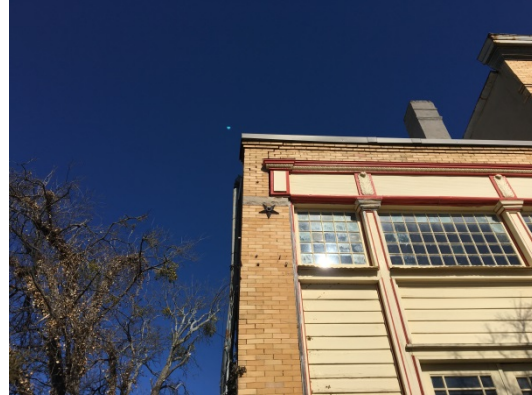
Figure 4. Cracking in south wall.

Priority Level 2: Repair the header and wall above of the east wall of the back room. This would require removal of the plaster to determine how the existing header is constructed. Portions of the existing structure may have to be shored to repair the header. Repoint the mortar joints in the south wall.

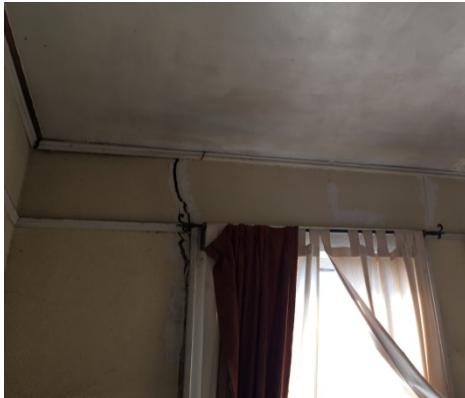
Fair. There are several cracks in the south wall of the west apartment. Most of the cracking is adjacent to the windows. On the exterior of the building there is separation of the brick and header over several of the windows. The floor joists appear to be structurally sound.

Figure 5. Crack at window in

Priority level 3: Cracks in the rooms are aesthetic in nature and should be repaired after repointing of the masonry is completed.

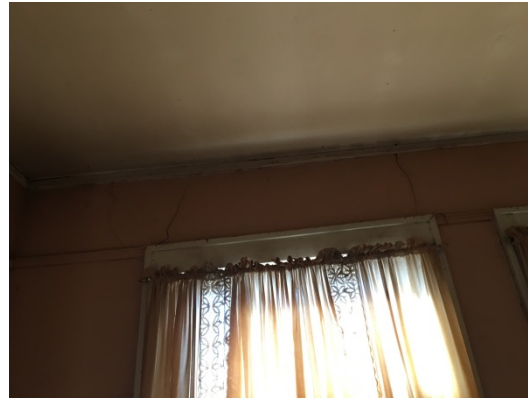
Figure 6. Cracks at window in Bedroom.
Living Room.

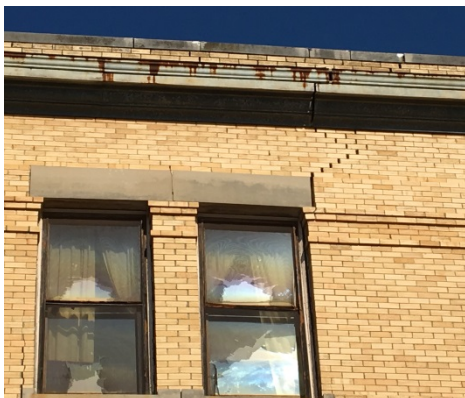
Figure 7. Exterior crack at Living Room.

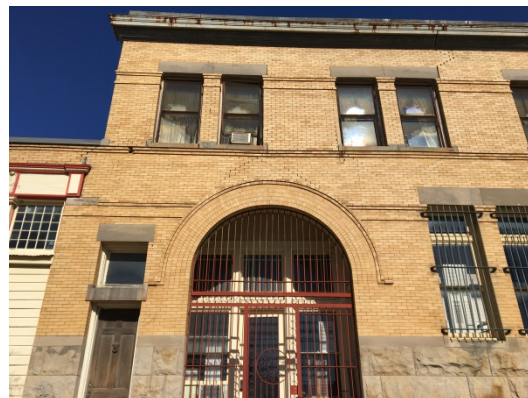
Figure 8. Exterior cracking at Bedroom.

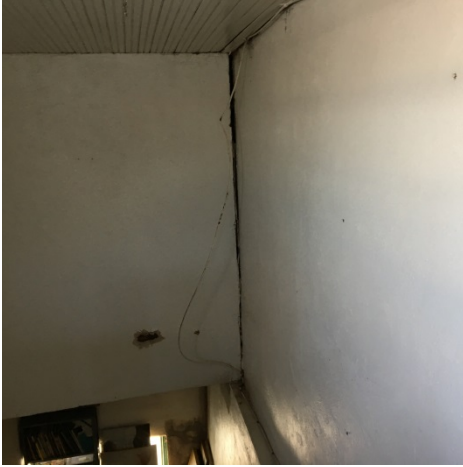
Figure 9. Separation of wall in stairwell.

Priority Level 2: Repair the portion of wall above the stair that has separated. Since this portion is wood, this will likely require the replacement of the header at this location. Shoring the existing roof may be required during this replacement.

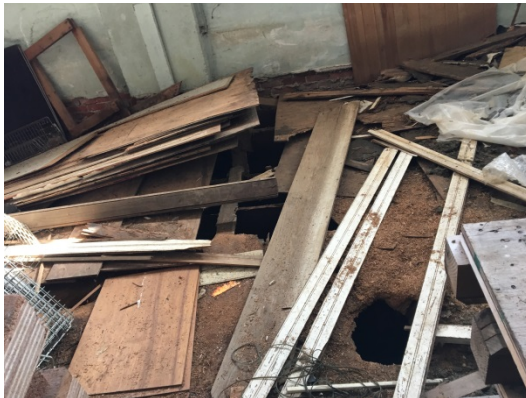
Fair to Poor. Near the east wall, the floor boards and several of the joists have collapsed. The x-bridging between floor joists has come apart between a lot of the joists. A large portion of the remaining floor boards in the east room have undergone major deterioration. Two of the newer support columns that were added have deflected slightly and reduced the beam bearing on the columns.

Figure 11. Collapsed floor near east wall.

The floor joists that have failed or are showing major signs of deterioration will need to be replaced. There were approximately 20 floor joists that will require replacement. The amount of floor board replacement will need to be determined once the stored items are removed from the space.

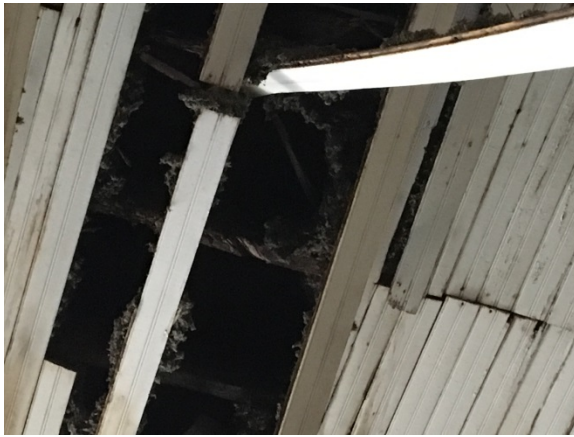
Fair to Poor. At the location of the roof leak, the bottom chords of several trusses are damaged. Without removal of the ceiling, condition of the remaining trusses cannot be verified.

Figure 12. Damaged bottom chord of truss.

Repair or replace damaged trusses. Verify the remainder of the trusses are structurally sound.

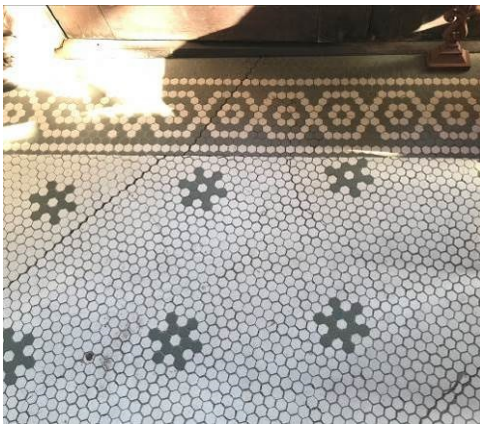
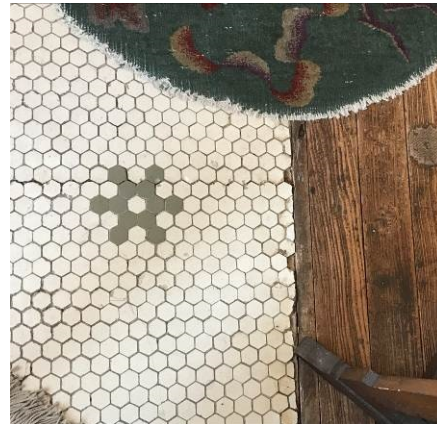
Tile pattern with visible large cracks and showing where the tile meets the stained wood floor, Oct. 2017

Infill missing tile with replacement tile, if available. If replacement tile is not available, salvage tile from a concealed location.

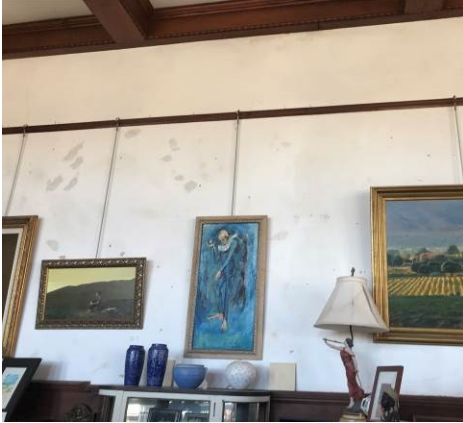
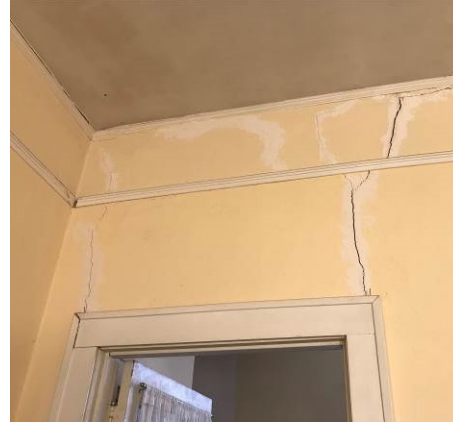
Plaster walls with unmatched paint touchups and cracks above windows and doors, Oct. 2017

Address building settlement, refer to the structural section. Repair cracks in plaster and repaint all walls.

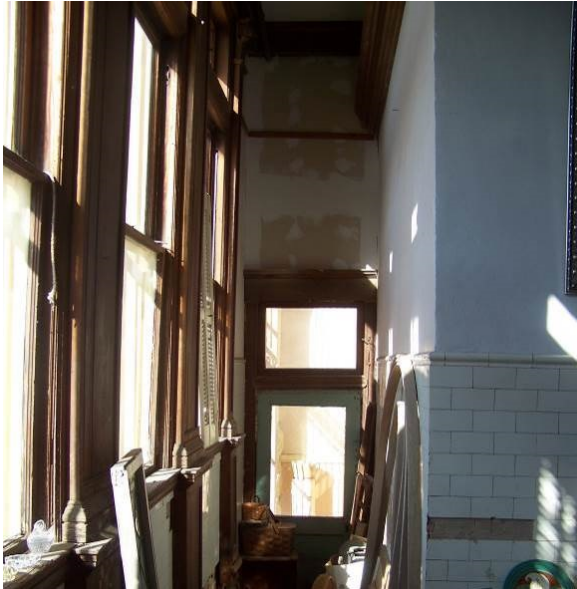
Unpainted gypsum board above an exterior door, Oct. 2017

Paint to match adjacent walls.

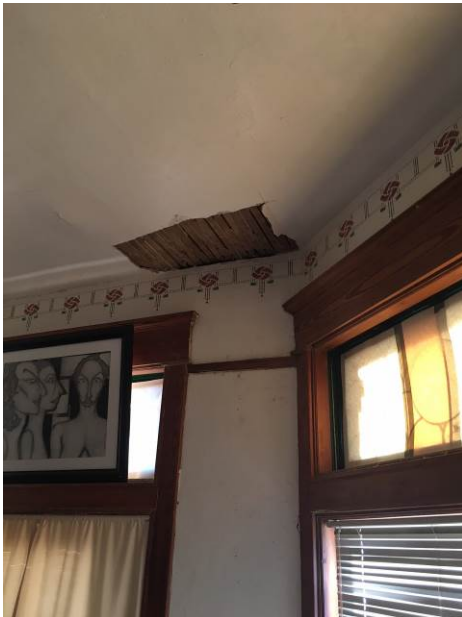
Large piece missing from plaster ceiling in second floor living room, Oct. 2017

Patch cracks and holes in ceilings. Repaint discolored ceilings.

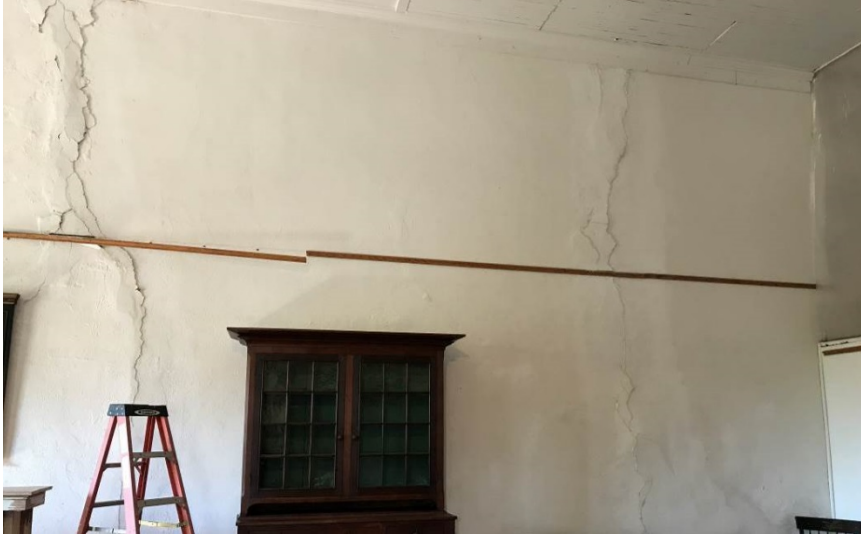
View of plaster walls showing large cracks from floor to ceiling, Oct. 2017

Repair cracks in plaster walls and repaint walls. Stabilize plaster on walls as required to prevent additional plaster loss.
