## BEICKER MARTINEZ ENGINEERING

August 8, 2013

Re: **Stein Building Investigation**  
Main Street  
Uvalde, Texas

BME Project #12413-1

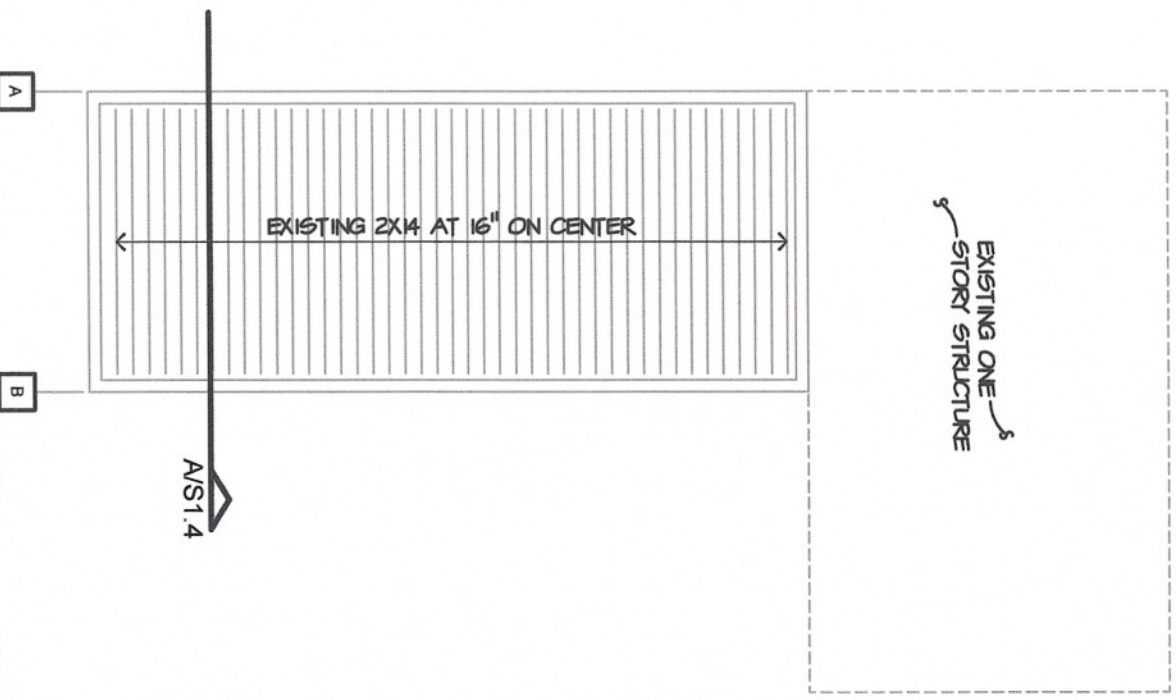
# Existing Second Floor Plan

The floor joists bearing into the south wall have deteriorated due to water/rot damage. These joists are located below the roof hatch and door-opening location from above and in my opinion water from these openings above is causing this damage. The damage to the joists is causing the joists to begin to lose bearing support at the masonry. The 1x4 floor decking has rotted at this location as well. Based upon the existing condition the second floor is not safe for loading (no one allowed to walk on second floor) until the floor joists and decking are repaired.
