**FARMERS AND MERCHANTS BANK
PILOT POINT, TEXAS
MASTER PLAN**

**Prepared for
Pilot Point Economic
Development Corporation
Pilot Point, Texas**

Quimby McCoy Preservation Architecture, LLP
3200 Main Street #3.6
Dallas, Texas 75226

February 28, 2018

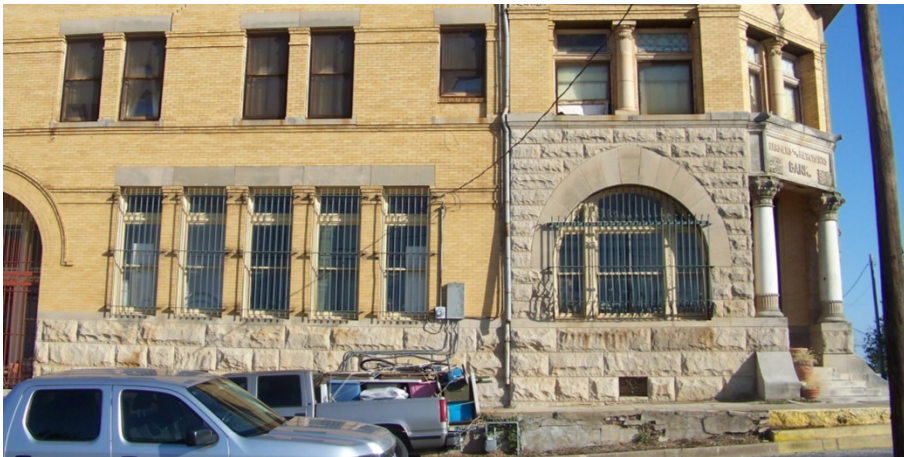
Rusticated limestone water table and entrance porch, Oct. 2017

Remove ivy, repoint open mortar joints and repair cracks. Clean biological growth and staining. Remove iron anchors and infill holes with marble Dutchman to match.

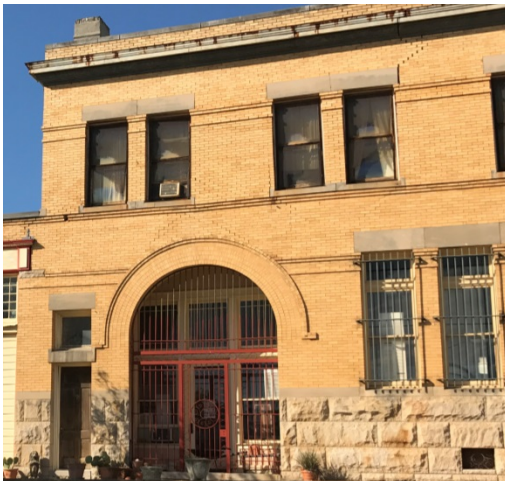
Tan pressed brick, Oct. 2017

Repair and repoint open mortar joints. Because the west wall will be rebuilt, the cementitious coating, which was not original, need not be reapplied to the reconstructed brick wall.

Refer to the structural assessment regarding the integrity and recommendations for the west wall.

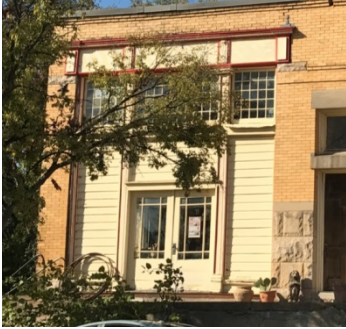
Painted wood siding, Oct. 2017

Remove wood siding and install appropriate wood storefront.

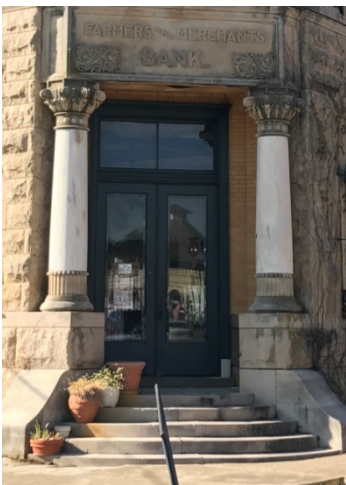
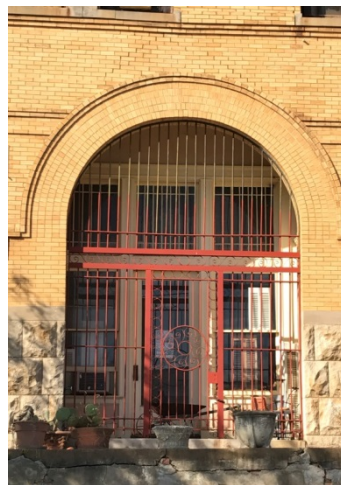
Main entrance, Oct. 2017

Arched entrance porch, Oct. 2017

Strip and repair deteriorated wood with Duchman's patch and repaint. Sand and re-stain door to second floor.

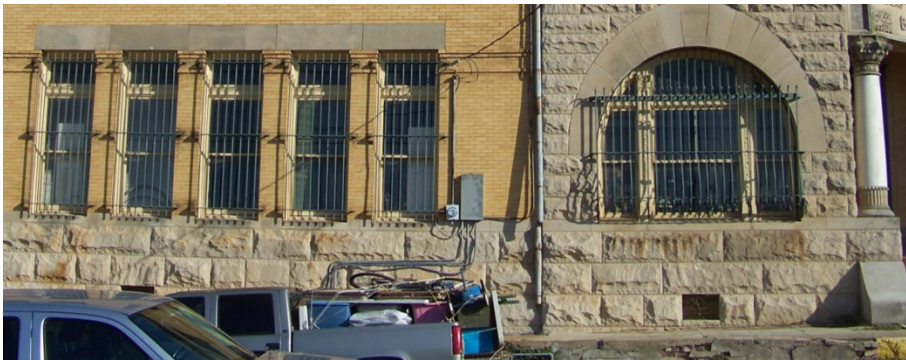
Wood windows, Oct. 2017

Repair deteriorated components. Replace missing screens.

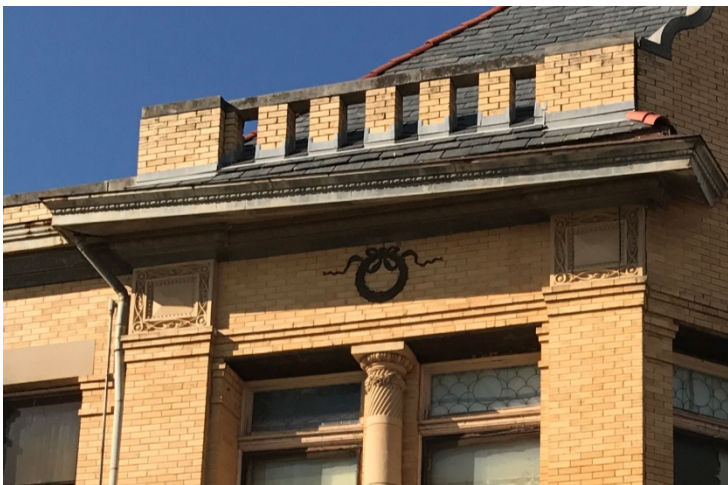
Pressed metal projecting cornice, Oct. 2017

Further study of the cornice is recommended to confirm the assumptions noted above in the condition. Reattach cornice and re-solder joints as required. Confirm condition of integral gutter, clean and repair as required. Replace missing downspouts.

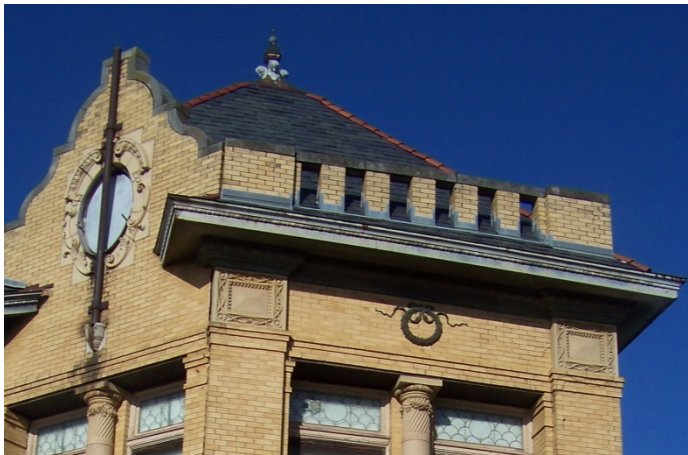
Square hipped gray slate roof, Oct. 2017

Solicit a roof inspector to review the roof and document conditions.

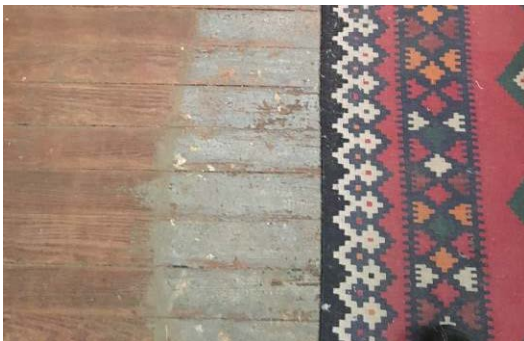
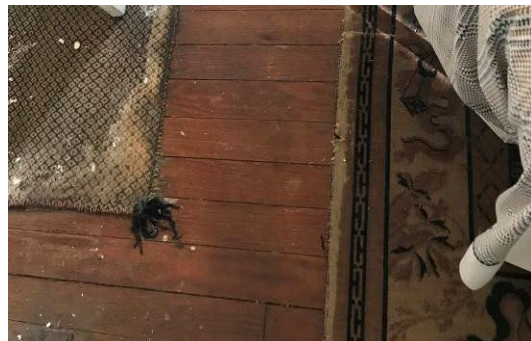
Blue gray paint on wood floor, Oct. 2017

Stained tongue and groove floor, Oct. 2017

Remove furniture and rug to view the floor in the dining room. Replace damaged flooring as required and refinish floors to match historic finish elsewhere.

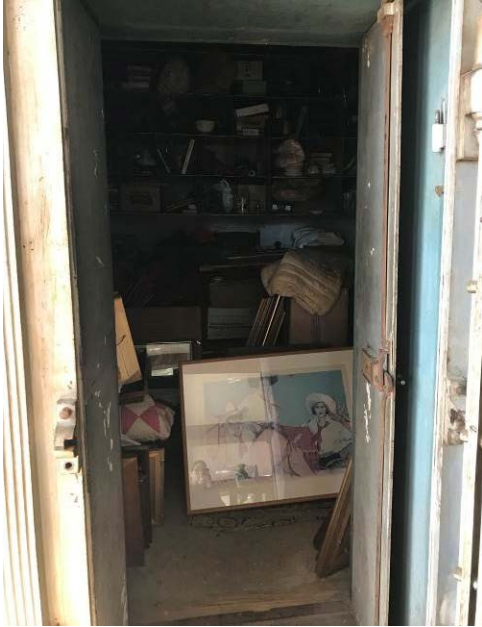
View of the bank vault with concrete flooring, Oct. 2017

Concrete floor obstructed, remove items to evaluate condition of the floor.

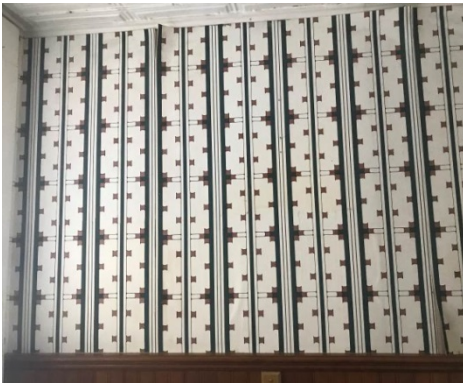
Wallpaper pattern in the second floor bathroom, Oct. 2017

Suggest re-adhering wallpaper where paper is peeling from wall. Consider removing the wallpaper and repairing plaster as required and repaint walls.

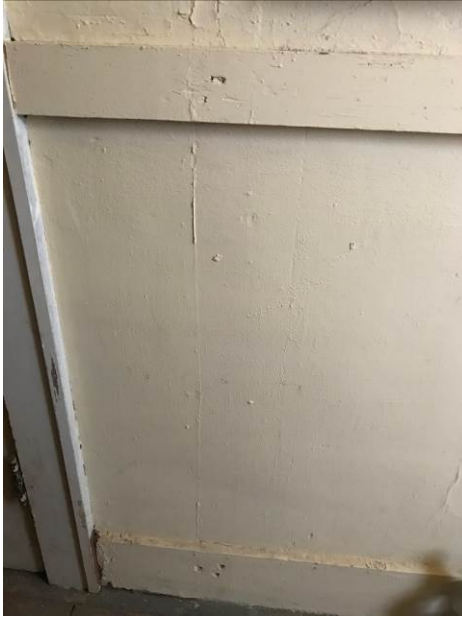
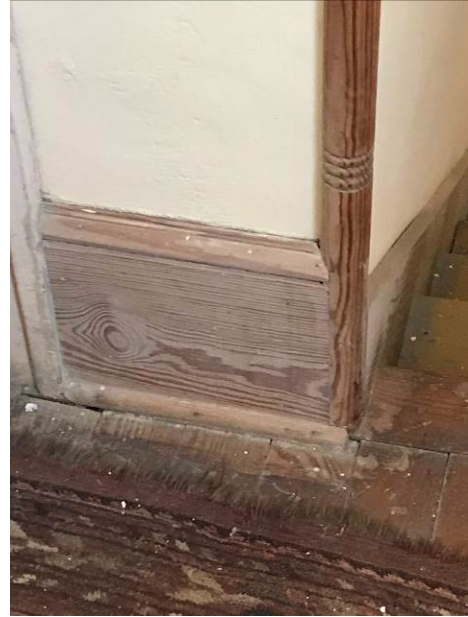
Simple base and chair rail, Oct. 2017

Stained wood wall base, Oct. 2017

No work required. Exception, in the bank Lobby, refinish base were necessary to match wood wainscot and reattach wood base below arched window at the east façade.

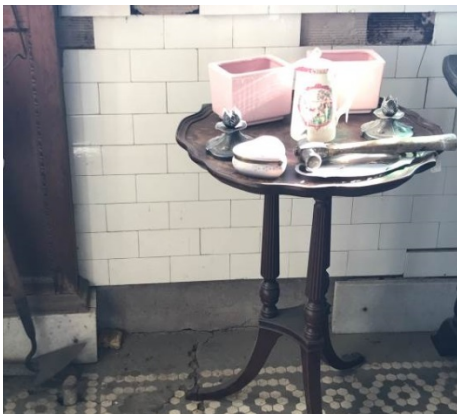
Marble wall base in the lobby, Oct. 2017

Reattach loose marble base and infill with matching base where required. If replacement base is not available, salvage base from a concealed location.

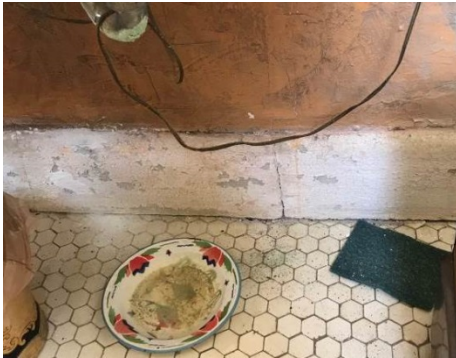
Masonry wall base in second floor bathroom, Oct. 2017

Sand surface to remove peeling paint and repaint base to match hexagonal tile.

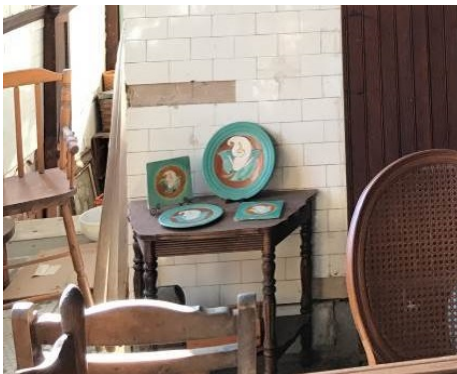
Tile wainscoting in the second floor bathroom and first floor lobby, Oct. 2017

Reattach loose tile and infill missing tile with replacement tile, if available. If replacement tile is not available, salvage tile from a concealed location.

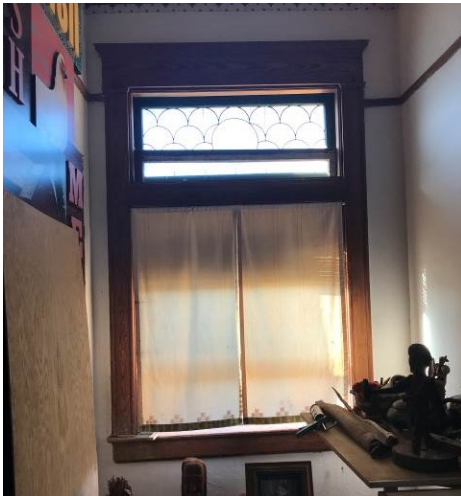
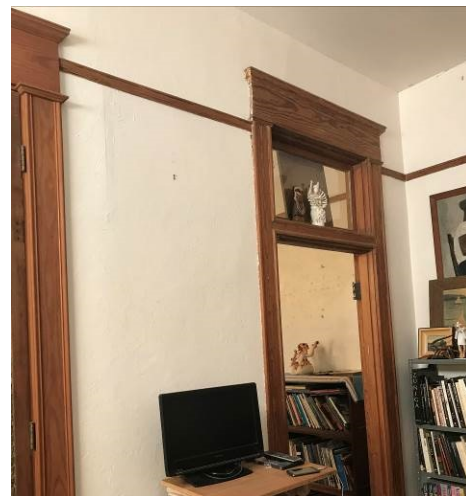
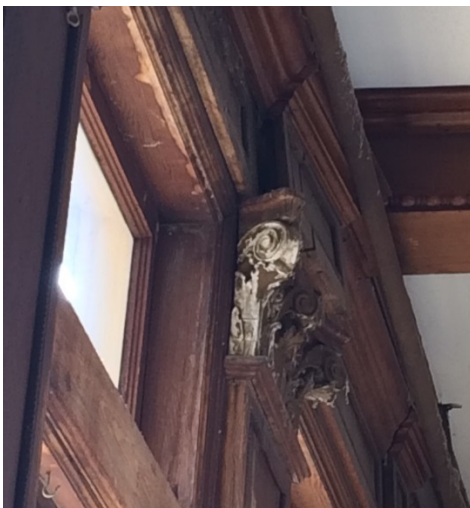
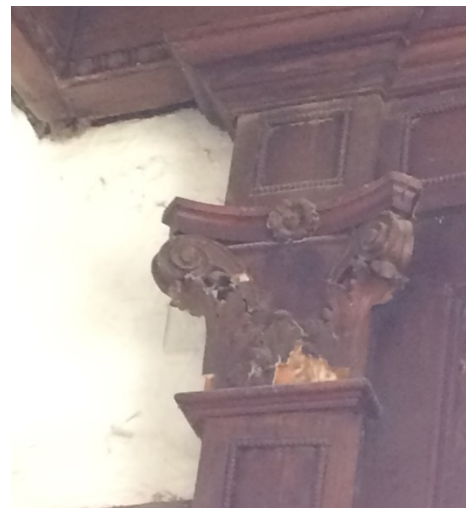
Molding and trim around transom windows and doors, Oct. 2017

Molding and trim around banking lobby windows, Oct. 2017

Repaint peeling wood moldings and base throughout building. In the bank lobby, repair damaged wood pilasters and window trim, reattach molding and trim where it is loose or detached from wall and refinish to match original color.

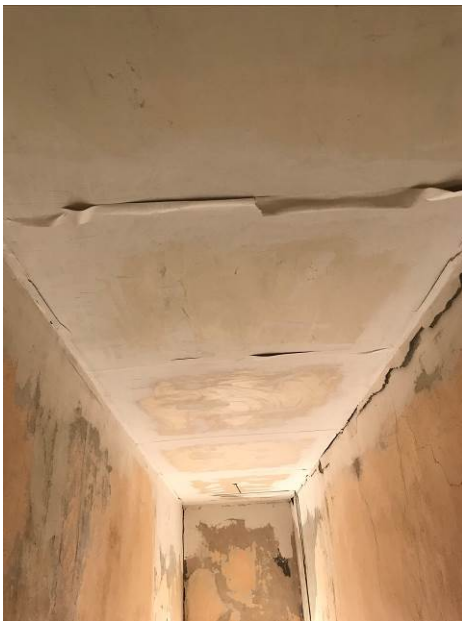
Sheetrock ceiling in stairway to second floor, Oct. 2017

Replace damaged or moldy gypsum board as required and repaint. Sand down peeling bedding tape and re-tape and bed board joints. Replace gypsum board with rusted screws and repaint.

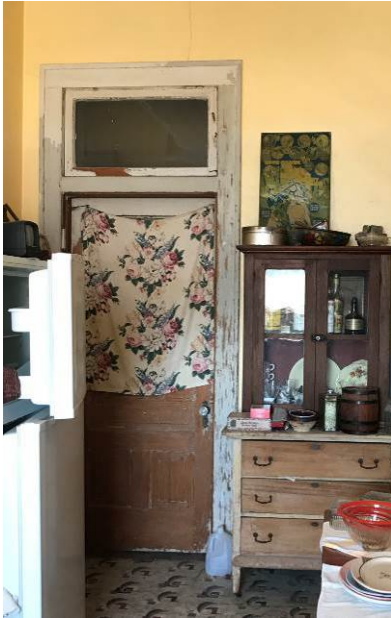
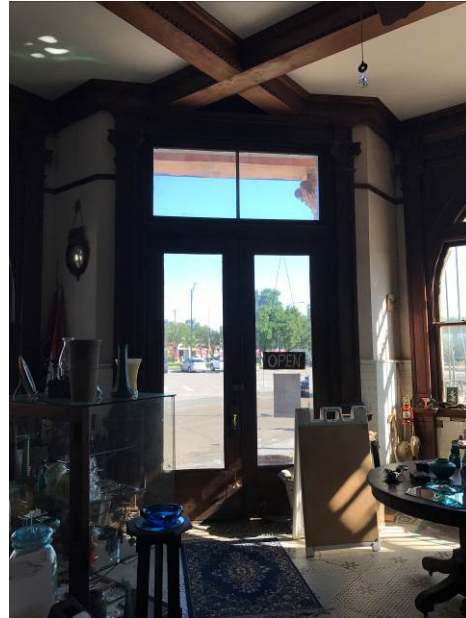
Transom window and door in second floor kitchen and first floor lobby, Oct. 2017

The doors in poor condition should have the paint or clear finish should stripped and repainted or finished to match original color. Adjust doors as required to ensure they remain operational.

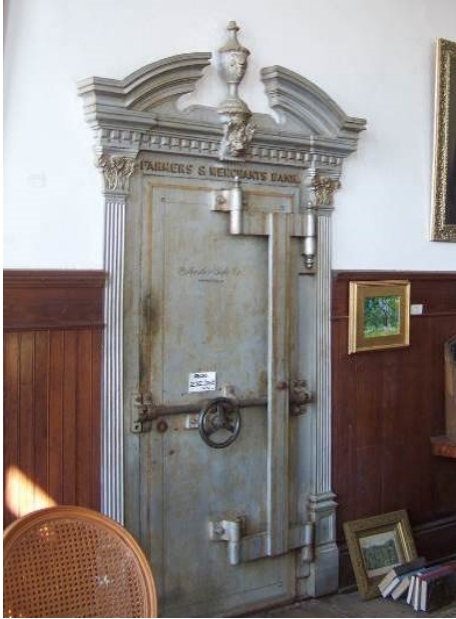
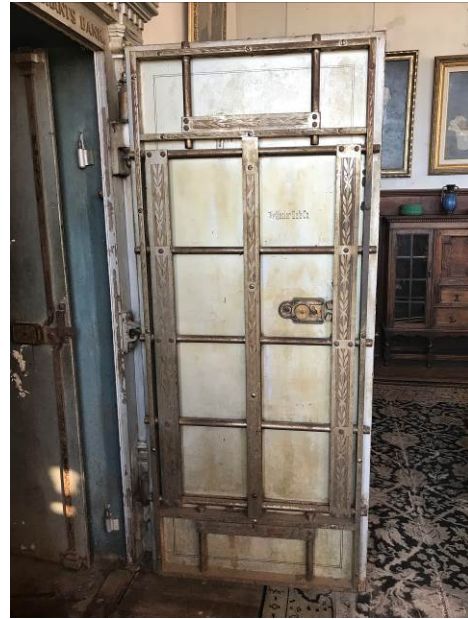
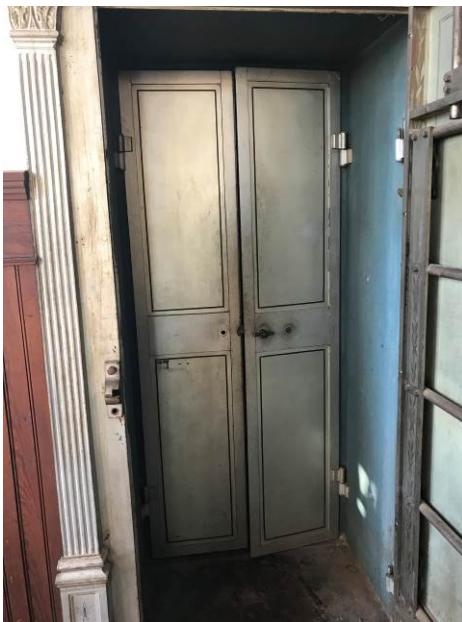
Exterior view of vault door, Oct. 2017

Inside view of metal bank vault door, Oct. 2017

Inner vault metal doors, Oct. 2017

Carefully remove rust and touchup paint in those areas only where the doors have been frequently handled.

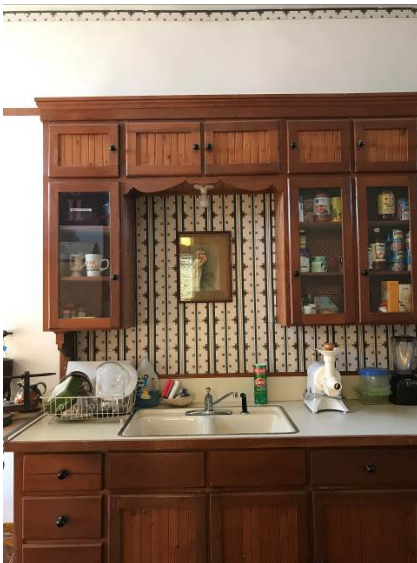
Built in second floor kitchen cabinetry, Oct. 2017

Replace peeling veneer countertop on historic cabinets in the west apartment. Use replacement veneer that matches original veneer.

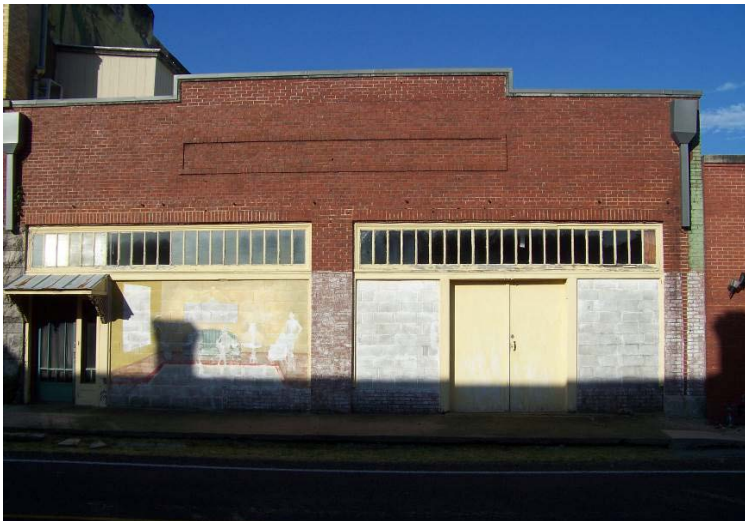
Condition

Remove CMU infill and construct storefront appropriate to the historic building. Remove paint from brick. Extend downspouts to discharge water at grade.

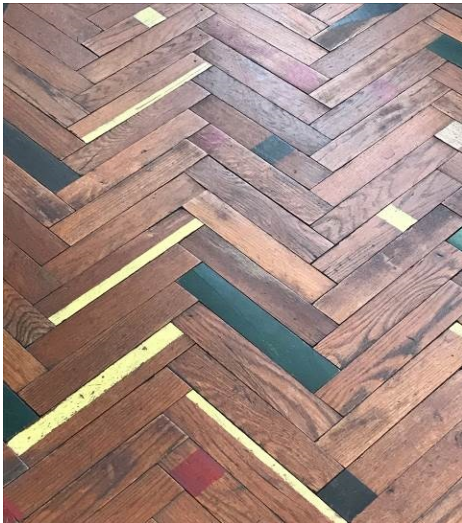
Good to Poor. The floor in room 106 is in good condition. The wood floor in room 107 is in fair condition. The majority of the floor in room 109 is obscured by furniture but is assumed to in poor condition because a portion of the floor along the east wall has caved in.

Reclaimed wood floor in herringbone pattern, Oct. 2017.

No work required to herringbone pattern floor. Replace the wood floors in Rooms 107 and 109 with wood floor to match original during building renovation.

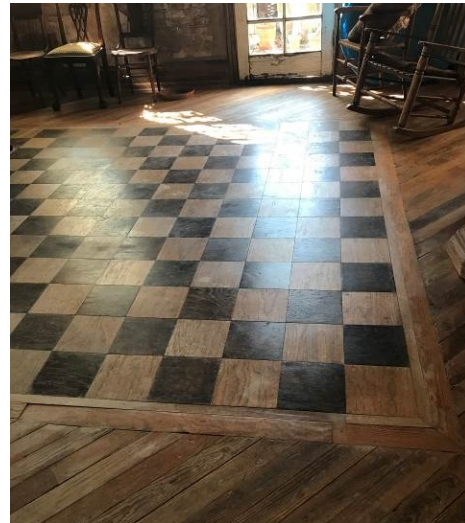
Checkerboard pattern with stained wood, Oct. 2017

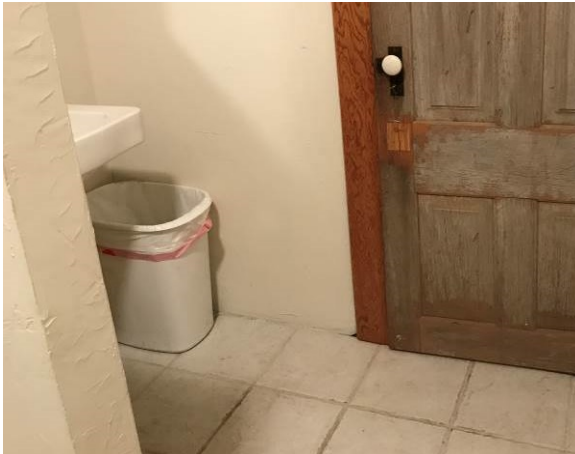
White ceramic tile in bathroom, Oct. 2017

No work is required. This material to be removed during the renovation.

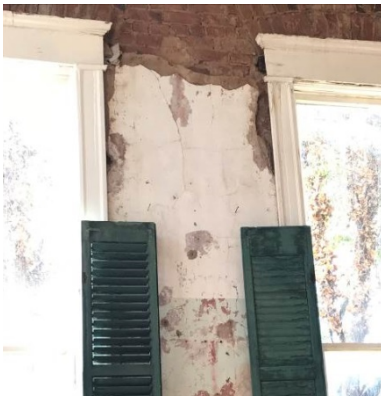
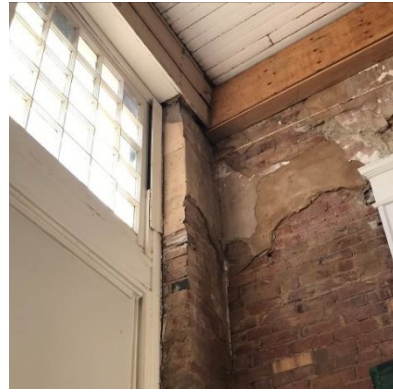
Fair to Poor. In Room 109, a significant portion of the plaster has fallen off the wall. The plaster is cracking at the north wall, leaving visible cracks that run from floor to ceiling. Smaller areas of cracking are visible in other walls. There are large cracks in the west brick wall and the wall itself seems to be separating from the building, leaving fissures between it and the dividing wall of the office space and open west area. The condition of the east brick wall is unknown due to the condition of room 109.

Exposed brick wall with partial plaster covering, Oct. 2017

Repair cracks in plaster walls and repaint walls. Stabilize plaster on walls as required to prevent additional plaster loss.

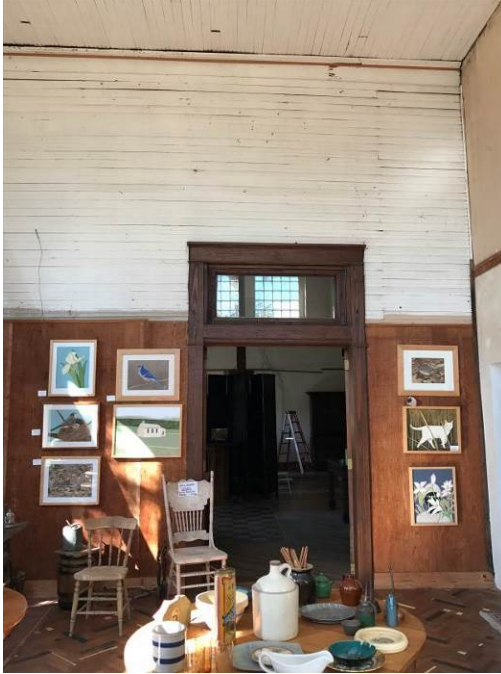
Fair. Some of the beadboard is loose or displaced at the top of the wall, likely from building settlement.

Beadboard and plywood ½ wall, Oct. 2017

Reattach any loose beadboard and repaint as required.
